REGARDING: HISTORIC RESOURCE EVALUATION OF 327 EAST BASELINE ROAD IN THE CITY OF SAN DIMAS, LOS ANGELES COUNTY, CALIFORNIA

HISTORIC RESOURCE EVALUATION OF 327 EAST BASELINE ROAD IN THE CITY OF SAN DIMAS, LOS ANGELES COUNTY, CALIFORNIA

±2 Acre Property

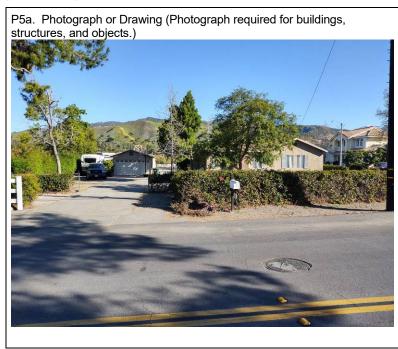
P5b. Description of Photo: (view, date, accession #) View looking north at the property. Photo taken on March 12, 2022. *P6. Date Constructed/Age and Source: ☑ Historic □ Prehistoric □ Both 1946, Los Angeles County Assessor *P7. Owner and Address: Ramon Nuno 2011 E. Financial Way, Ste. 203 Glendora, CA 91741 *P8. Recorded by: (Name, affiliation, and address) Jennifer Gorman, M.H.P. L&L Environmental, Inc. 721 Nevada Street, Suite 307 Redlands, CA 92373 *P9. Date Recorded: March 28, 2022 *P10. Survey Type: (Describe) Intensive Pedestrian *P11. Report Citation: (Cite survey report and other sources, or enter "none.") L&L Environmental, Inc. (J. Gorman). 2022. Historic Resource Evaluation Report of 327 East Baseline Road in the City of San Dimas, Los Angeles County, California.

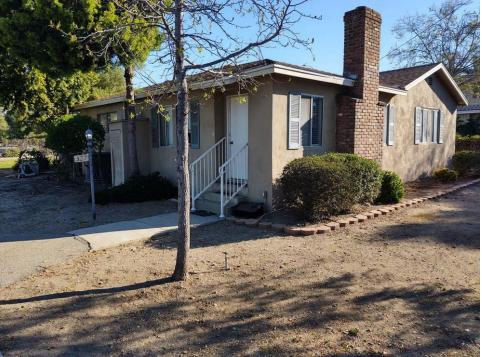
The main house is a single-story residential building with concrete foundation, near rectangular plan, smooth stucco siding, and an irregular roof featuring a front gable section and hipped roof types. The roof has composition shingles. The primary entrance is on the west façade of the building. A concrete walkway leads to three concrete steps with metal railings that lead to a flush wood door. This entrance is on the southern end of the west façade. To the north of the front door are three slider windows; one is metal and the other two are vinyl, each with a single wood shutter. The south façade features a brick chimney and four vinyl slider windows. The east façade features four windows: two vinyl sliders, a tripartite wood window with wood muntin, and two tripartite vinyl windows. The south façade features a front gable projection with two triangular windows located underneath the gable peak. This façade also features a corner porch that is covered with a wood pergola. The porch has a wood deck and wood steps with a wood railing. Within the porch are two metal slider windows and a large vinyl sliding door.

View of the southwest oblique and primary entrance of the main house looking northeast.

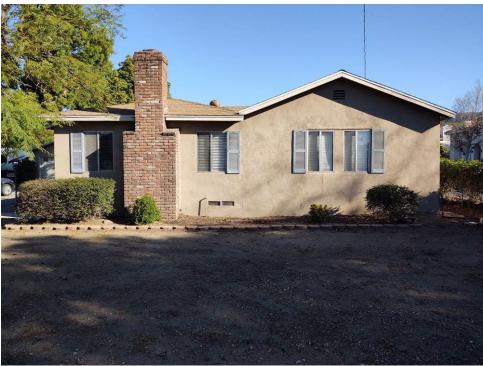
Modifications to the building include the stucco siding, replacement windows and doors. According to historic aerials, an addition was built sometime between 1972 and 1978 on the south façade. According to building permits, the fireplace was added in 1961, the kitchen was remodeled in 1999, and the sewer line repaired and the roof replaced in 2009.

View of the south façade of the main house looking north.

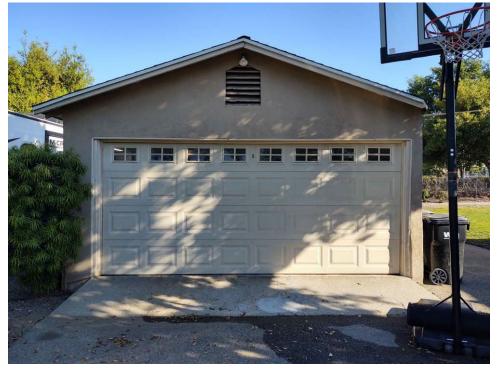
The garage is a single-story ancillary building northwest of the main house. The building features a concrete slab foundation, smooth stucco siding, and a front gable roof clad in asphalt shingles. The roof features exposed rafter tails within the eaves. The primary entrance is on the south façade and features a metal roll-top garage door with partial glazing. The east façade features a single pedestrian door flanked by a sidelight. The rear (south) façade features a partial-width porch supported by wood posts and a hipped roof. Within the porch is storage equipment. There is a single pedestrian door on this façade. There are two windows located on the west façade; one that is a metal slider covered by security bars, and the other that is a fixed wood window. Modifications to the garage include the stucco siding, replacement windows and doors.

View of the south façade of the garage looking north.

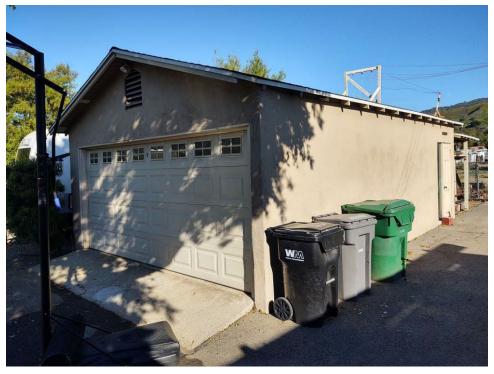
View of the southeast oblique of the garage looking northwest.
