GEOTECHNICAL EVALUATION REPORT

PROPOSED SEVEN-LOT SUBDIVISION TENTATIVE TRACT 83304 CHEROKEE COURT SAN DIMAS, CA 91773

> JULY 19, 2021 JOB NO.: 21-061

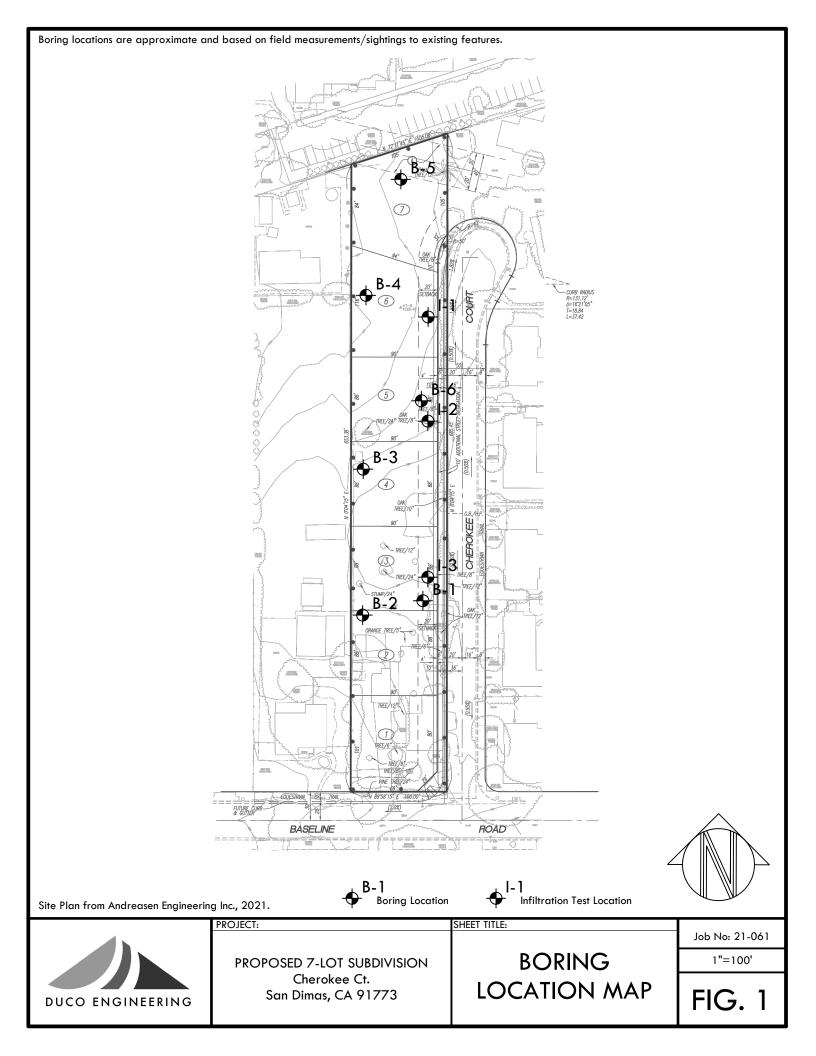
PROJECT: Proposed 7-L	ot Subdivision		JOB NO.:	21-061	TEST HOLE NO).: 1
CLIENT: Development 1					DATE:	7/2/2021
LOCATION: E PL, See P	'lan				ELEVATION:	1029.7
LOGGED BY:	JC	EXCAVA	FING EQUIPMENT:	8"	Hollow Stem Auge	r
DEPTH TO WATER:		None	CAVING:		None

SUMMARY OF SUBSURFACE CONDITIONS: This log is part of the report prepared by Duco Engineering, Inc. for this project and should be read together with the report. This summary applies only to the location of the test hole at the time of the excavation. Subsurface conditions may differ at other locations and may change at this location with the passage of time. The data presented is a simplification of the actual conditions encountered.

Π						SAMPLE	DATA	
	SAMPLE	BLOW	SOIL TYPE	GRAPHIC LOG	NSCS	DESCRIPTION	HELD MOIST. % OF DRY WT.	DRY DEN. Lb./Cu. Ft.	% COMP
0			A		SM	0-2.5', FILL/DISTURBED NATIVE, silty sand and gravel, scattered cobbles and debris, loose, grey-brown, dry to dry-damp			
			B		SM/ GM	2.5-15.5', SILTY COARSE SAND WITH INTERBEDDED GRAVEL, firm, tan-grey, subangular gravel, dry-damp, cobble stratum at contact	1.9		
- 5 -		11,10,15				Cobble	2.2	113.6	86.1
- 10 -		47,50				Cobble and gravel	3.5	116.5	88.3
- 15 -		8,15,28	с		SP/GP	15.5'+, COARSE SAND AND GRAVEL, grey, very firm, damp	4.0		
- 20 -									
- 25 -						EOB

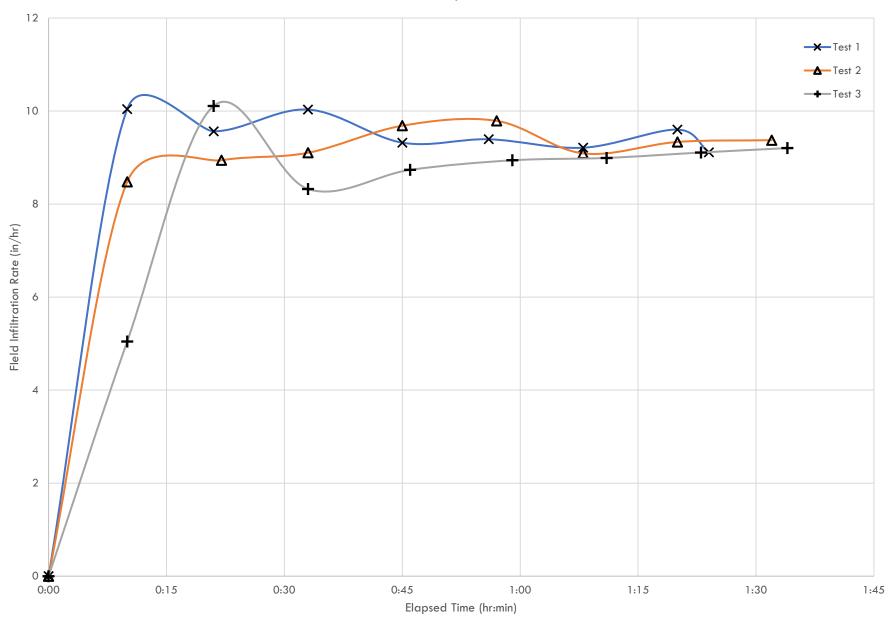
DUCO ENGINEERING Fig No.: 12

Infiltration Study Field Rates
